FRONTIER LAKE DAM  
WAYNE COUNTY, MISSOURI  
MISSOURI INVENTORY NO. 30007

PHASE I INSPECTION REPORT  
NATIONAL DAM SAFETY PROGRAM

PREPARED BY: ST. LOUIS DISTRICT CORPS OF ENGINEERS  
FOR: GOVERNOR OF MISSOURI

Name of Dam	Frontier Lake Dam
State Located	Missouri
County Located	Wayne County
Stream	Camp Creek
Date of Inspection	12 July 1978

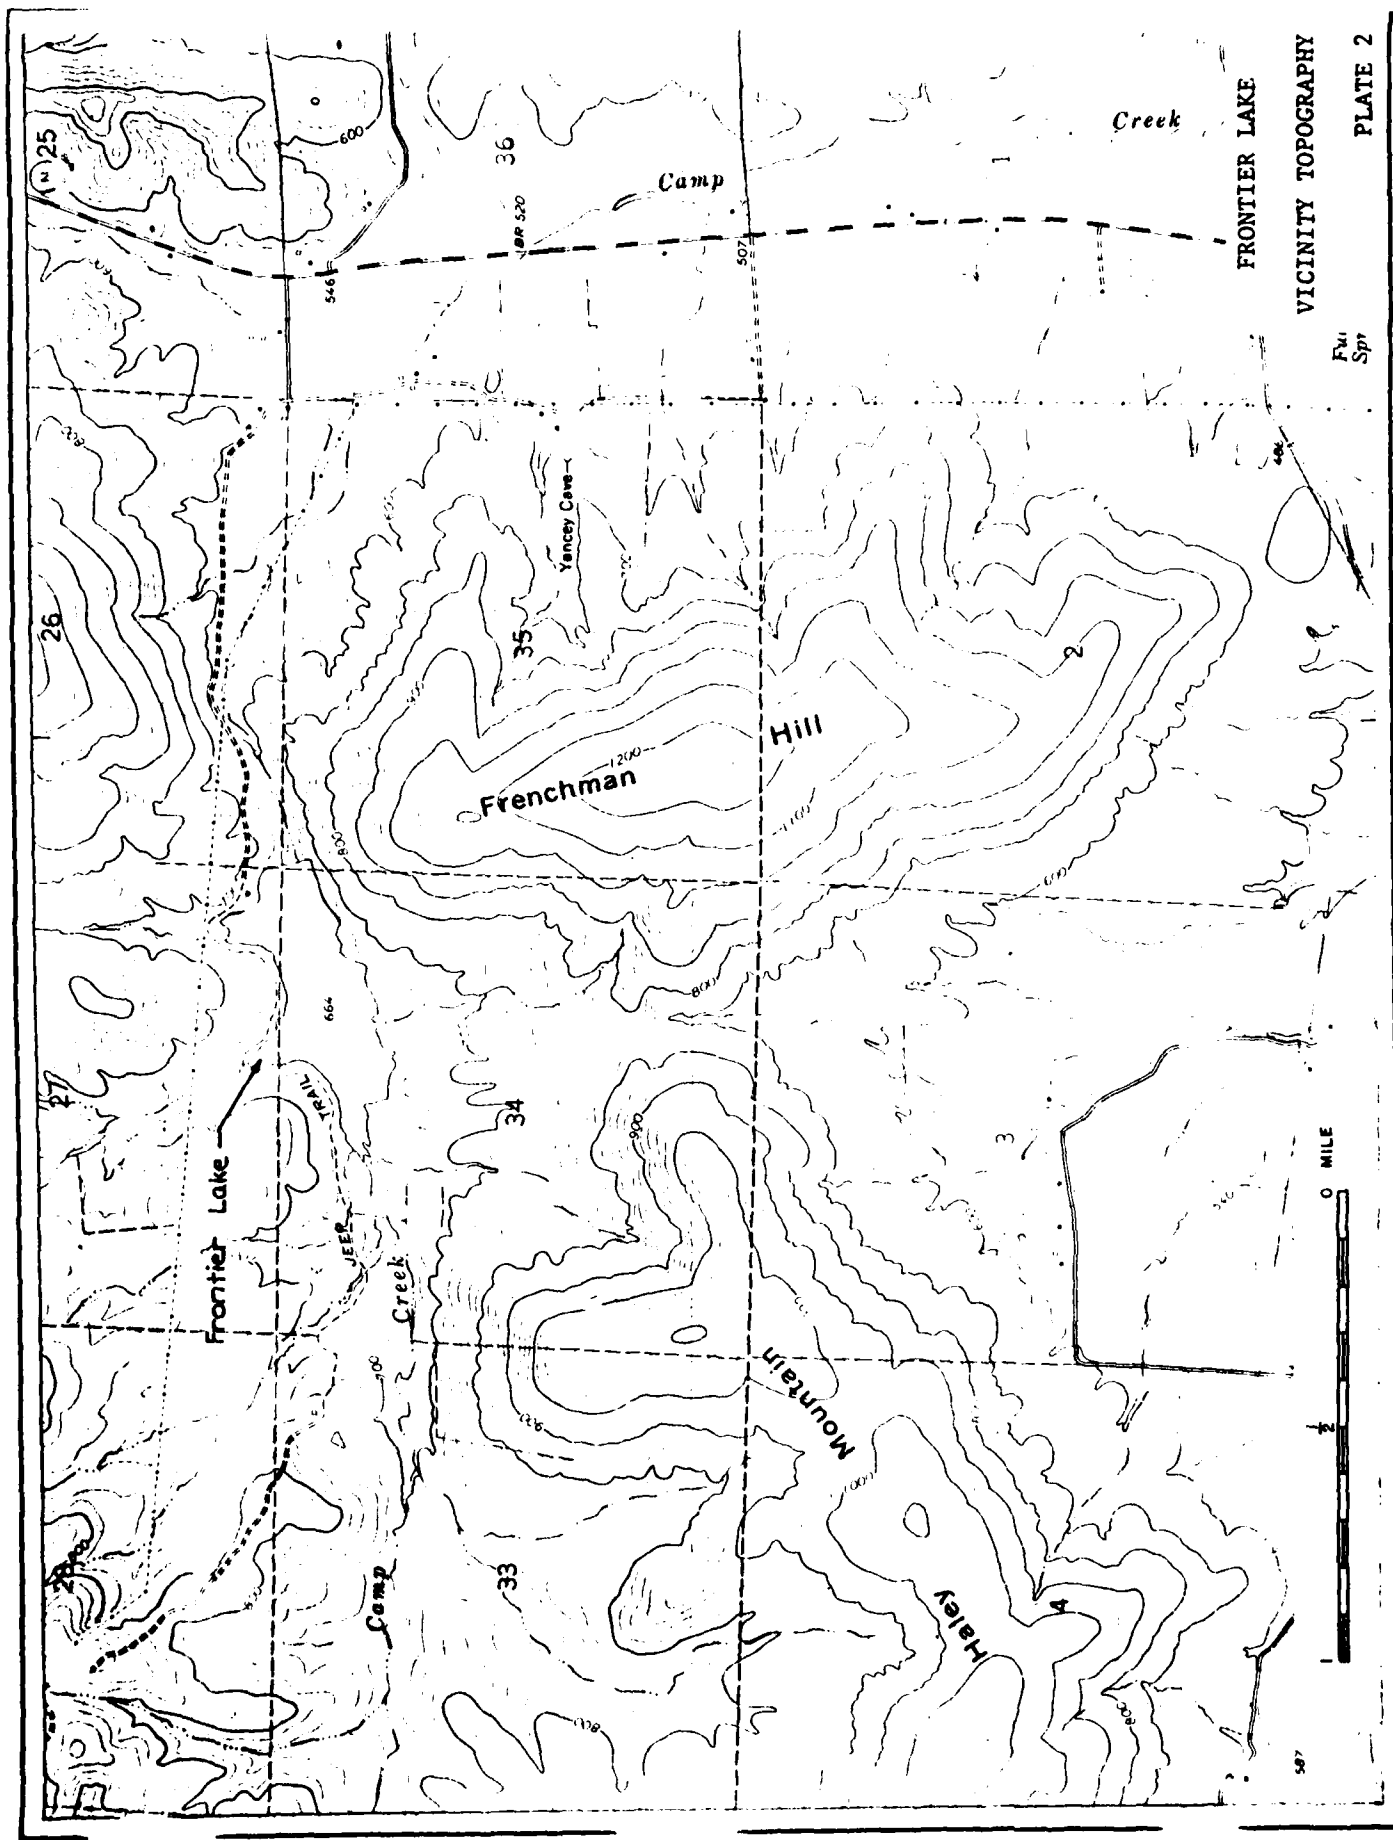
PLATE 2

VICINITY TOPOGRAPHY

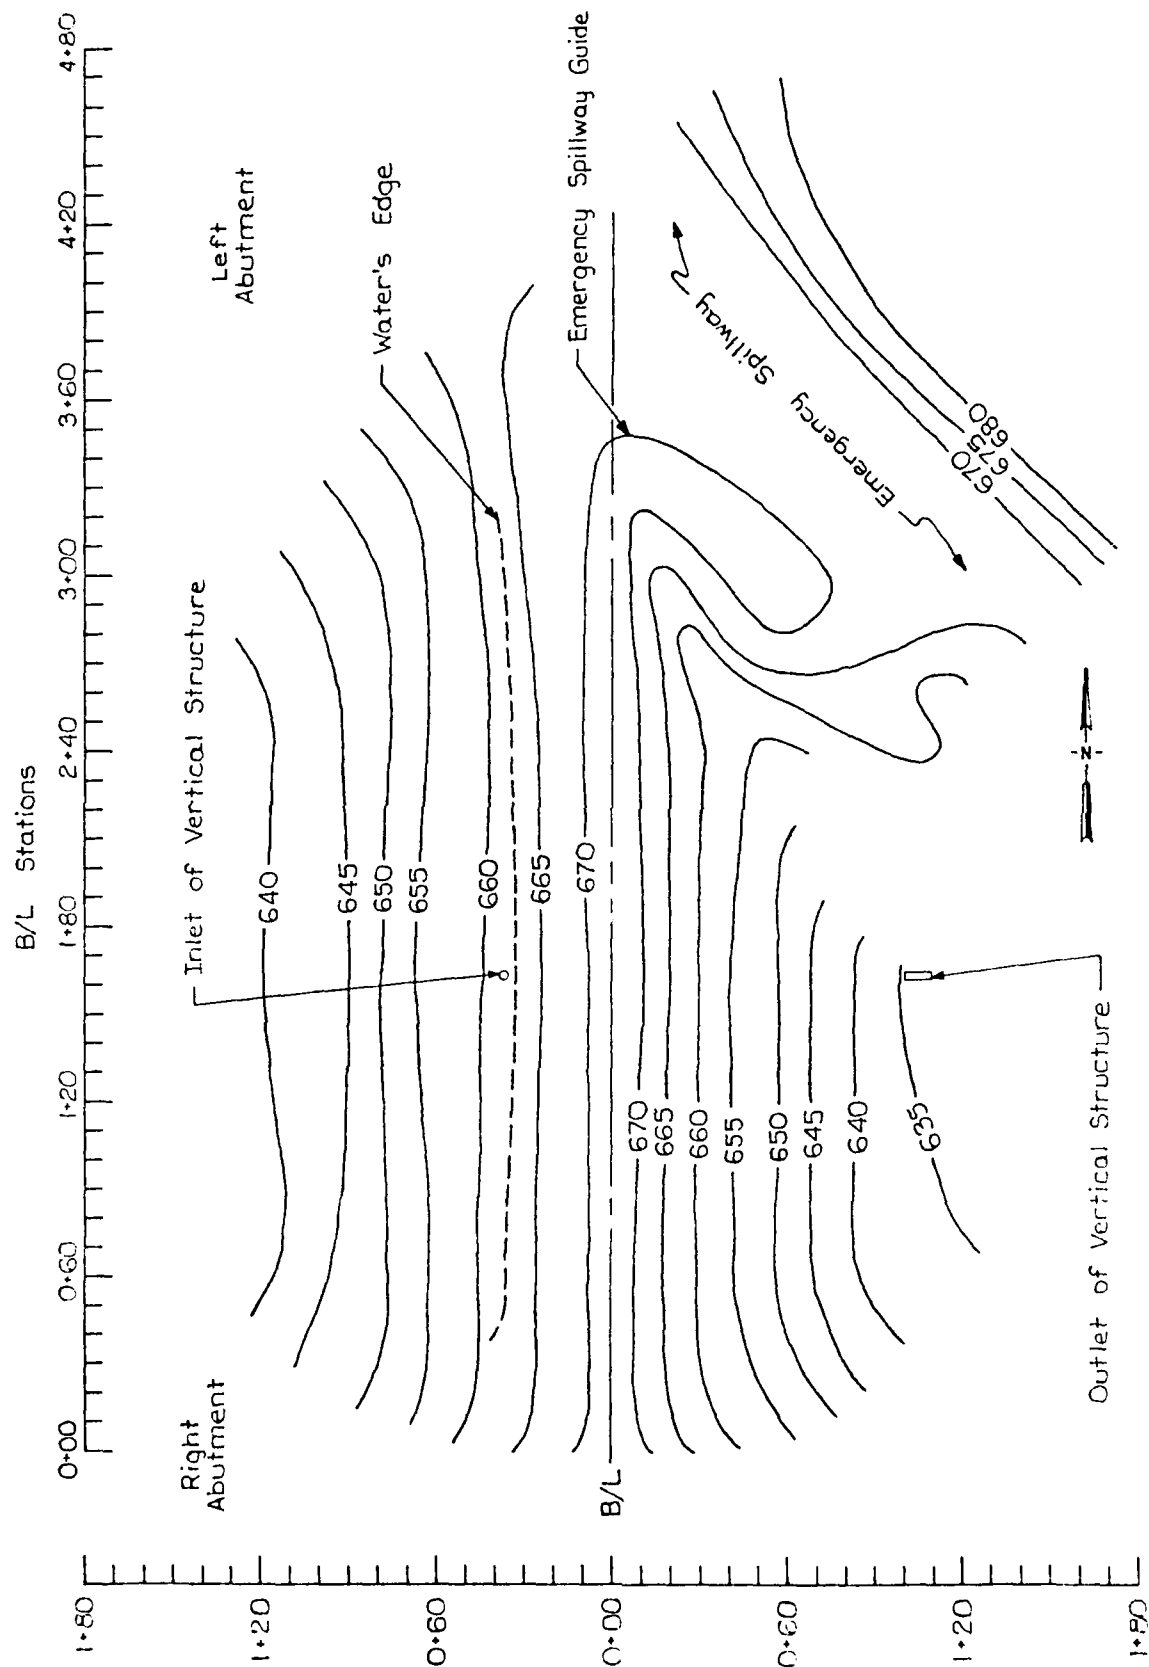
PLATE 3

The spillway is paralleled by a guide dike or berm which diverts the spillway outfall from the dam embankment (see Plate 3). The end of the spillway guide dike has been eroded toward the dam embankment

DAM PLAN VIEW

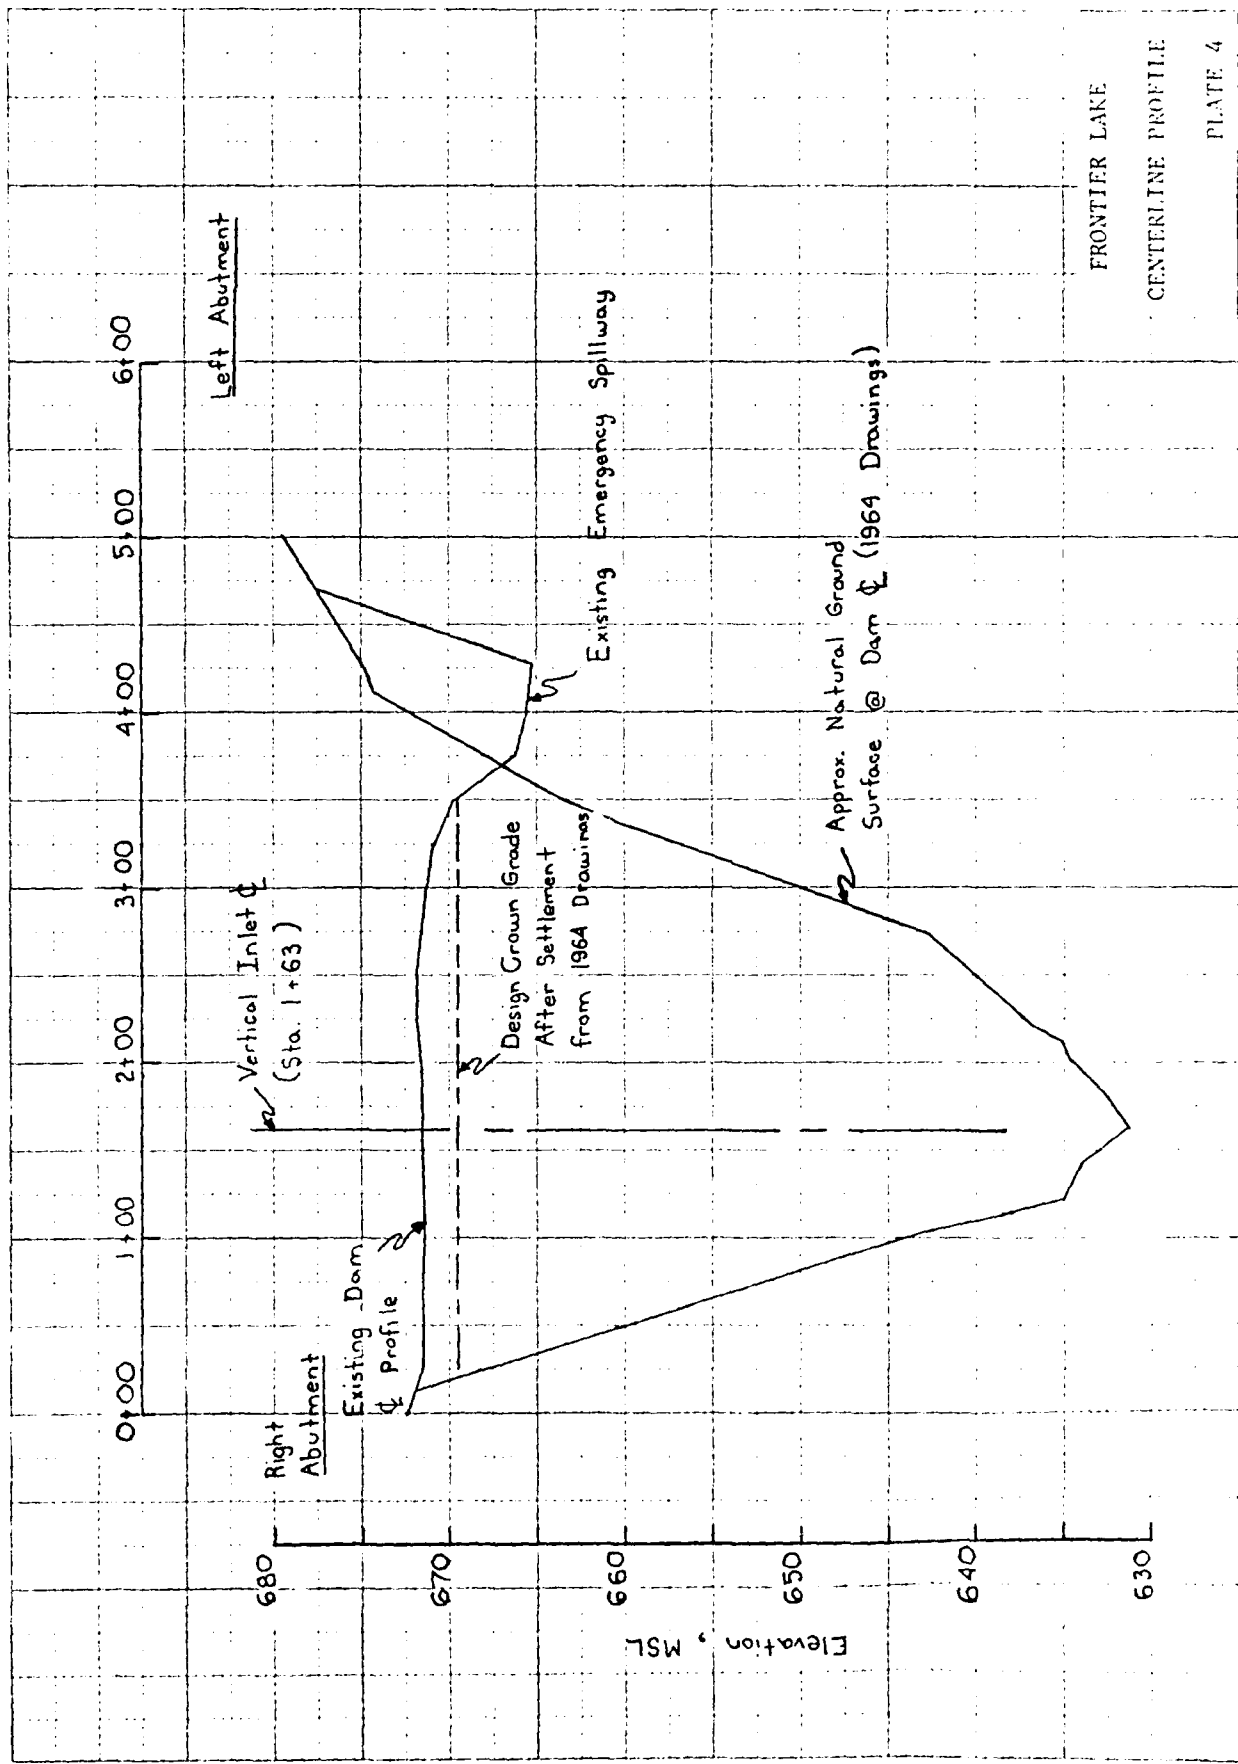
FRONTIER LAKE  
CENTERLINE PROFILE  
PLATE 4

- (2) Estimated experienced maximum flood at the damsite - 180 cfs.
- c. Elevation (Feet above M.S.L.)
  - (1) Top of dam -  $671.5 \pm$  (Existing, see Plate 4).  
 $669.6 \pm$  (1964 Design, see Plate 4).
